# ANALYSIS OF A DOUBLE FATALITY FIRE ALLEGEDLY CAUSED BY A PORTABLE ELECTRIC HEATER

HOW POOR METHODOLOGY CAN LEAD TO THE WRONG CONCLUSION

**Jeffery H. Warren, Ph.D., P.E., CSP, CFEI**  
THE WARREN GROUP, INC. - USA

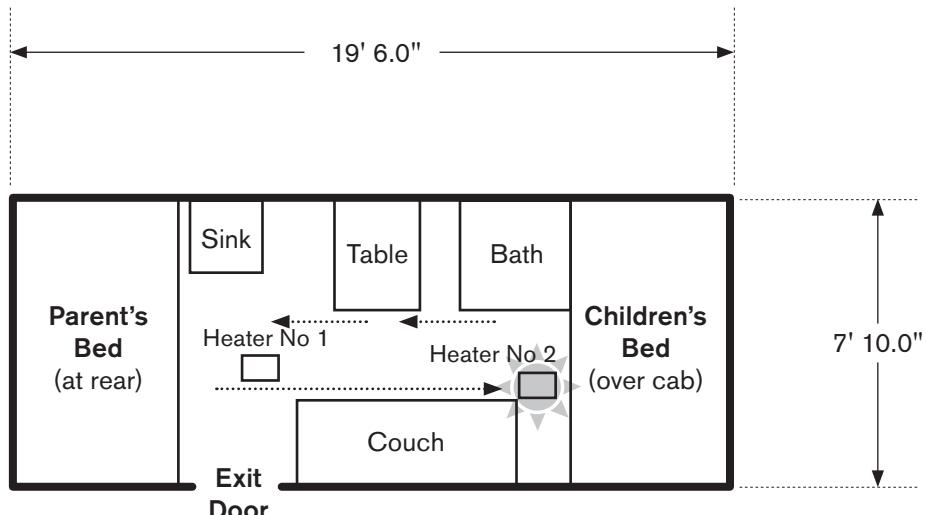
FIGURE 1 // R.V. LAYOUT

The fire was first observed near the children in the area where the second heater would have been located. The dotted block arrows indicate the travel path of the stepfather as he attempted to reach the children during the fire.

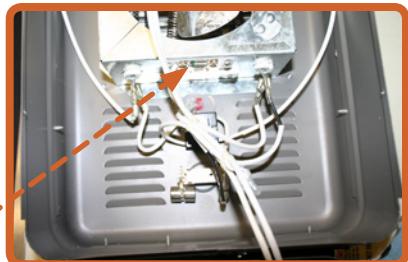
**FIGURE 3 // THERMAL FUSE**

The heater in question was equipped with two safeties to prevent a fire hazard. The first was a combination regulating thermostat and tip-over switch. The tip-over switch was designed with a pendulum weight attached to a polycarbonate plastic arm that opened the electrical circuit if the heater tipped over in either the forward or backward direction. The thermostat also opened the electrical circuit if the desired room temperature was reached. The second safety was a thermal fuse element that would open the electrical circuit due to high temperature.

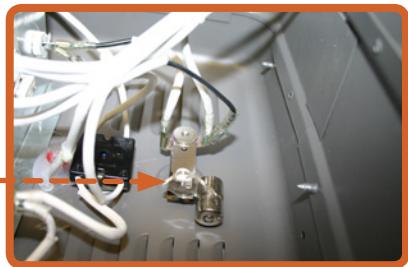
**FIGURE 4**  
Combination thermostat/tip-over switch with polycarbonate plastic arm and arm-pin

In further analysis, the metallic remains of the tip-over switch of the incident unit were ultrasonically cleaned and a model number for the switch was obtained. The model number corresponded to the model number for the tip-over switches installed in the exemplar heater units. An exemplar switch was removed from a heater and submitted to a materials laboratory at MIT for testing of the pendulum material. The materials engineer reported that the plastic arm pin was constructed of polycarbonate. "Polycarbonate (PC) is a high performance amor-

phous engineering thermoplastic with exceptionally high impact strength, clarity, heat resistance and downward dimensional stability." The materials engineer opined that the engineer hired by the plaintiff had an unfounded opinion regarding the failure of the cutoff switch due to impact. He stated that polycarbonate is one of the least brittle, if not the least brittle, plastics known. It is used in critical situations where high toughness is required such as bullet proof glass or canopies for jet fighter aircraft or safety helmets. It would never fail in a brittle manner due to handling stress. The incident heater was approximately one year old, had been used very little and according to deposition testimony had never been tipped over or otherwise damaged. It is highly unlikely that the plastic arm pin of the tip-over switch failed as suggested by the plaintiff's engineer.

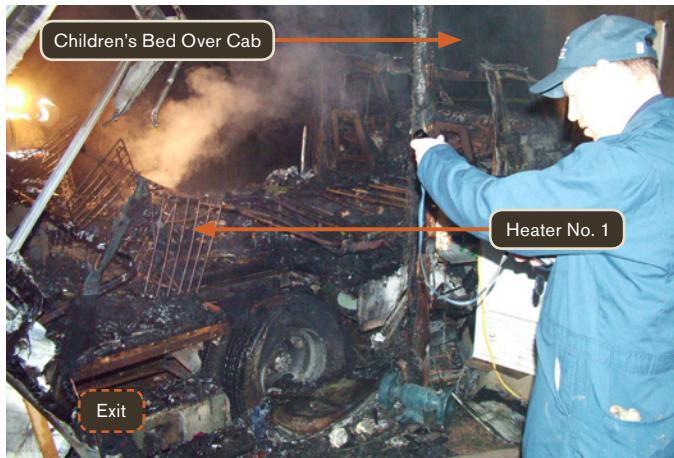
**FIGURE 5**  
Right side view of burned R.V.

The R.V. unit with its contents and furnishings formed a small volume with a large fuel load, all of which were fully involved and largely consumed during the fire, with floor level burning occurring throughout the R.V. The ceiling and walls, with the exception of the rear wall, were completely destroyed. There were no fire patterns that provided a scientific basis for establishing the origin area of the fire.

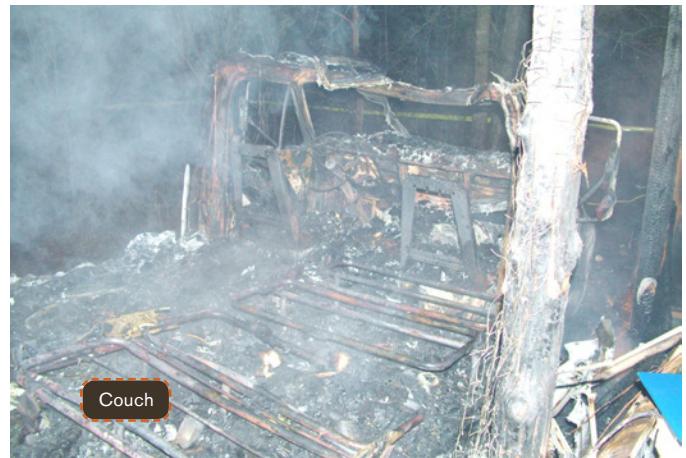
**FIGURE 6**  
Right side view of burned R.V. looking towards cab

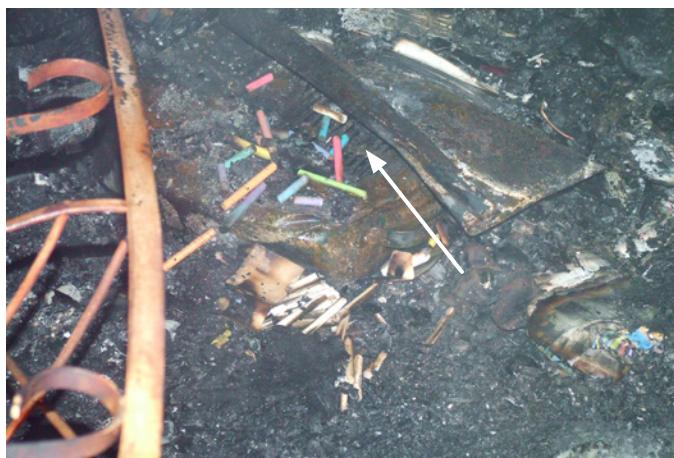
**FIGURE 7 // HEATER NO. 1 PRIOR TO EXCAVATION**  
The arrow points to the heater beneath debris

The position of the heater, as reportedly found after the fire, does not

indicate that it was in a tipped over position prior to the fire. The structure was destroyed by the fire. With the exception of one wall, all of the walls and the ceiling/roof structures and sheathing burned and collapsed. It is well known that falling debris in a structure fire will impact and move or shift objects that it comes into contact with as it is falling. The heater housing was bent and deformed and therefore clearly sustained impact damage during the fire incident. Given the level of fire destruction and collapse incurred to the R.V. structure and the condition of the heating element coils and internal wiring of the heater, it is most probable that the heater first lost electrical power and was sometime later knocked over during the course of the fire event or during extinguishing efforts, and not before the fire.

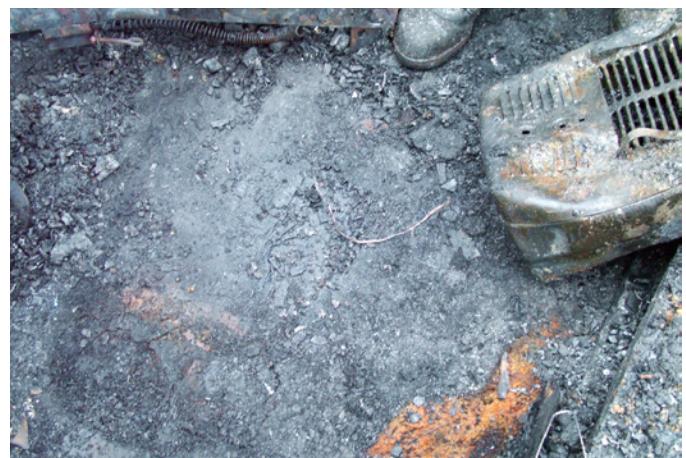
**FIGURE 8**  
Heater No. 1 and floor beneath post-excavation

There was no scientific basis for saying that the burns on the floor beneath the location of where the heater was found or that the burn patterns on the heater itself indicate the fire originated at the heater or that the heater caused the fire. The entire structure and contents burned extensively and nearly to completion in this incident. The high temperatures at the floor level generated either by flashover conditions, a fully involved fire, or by fall down burning, will clearly damage the flooring and heat up metallic objects such as the housing of the heater. Metallic objects heated during a fire can transmit heat via conduction heat transfer into combustible materials such as the carpeting that is in contact with it, causing subsequent pyrolysis, charring and ignition of the combustibles. Furthermore, the heater is not a solid appliance but has vent openings on both the front and the back sides. Consequently, heat can also be transferred via convection and radiation through the heater openings to the flooring.

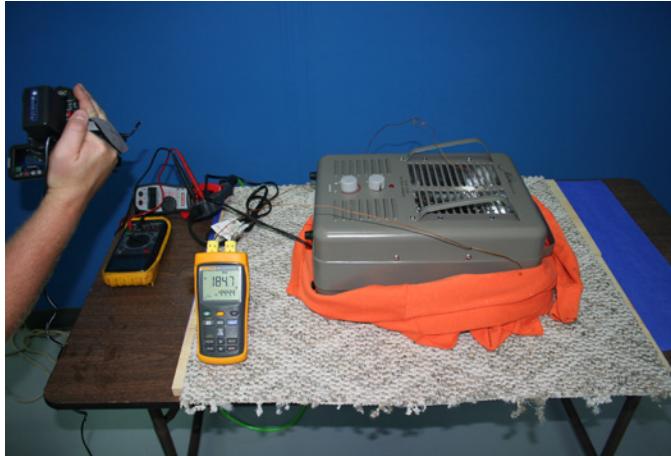
**FIGURE 9**  
Rearward tip over endurance test

In one set of tests, the unit's tip-over switch was bypassed to determine the maximum casing temperature and flooring temperature when the heater was fully tipped over in both forward and rearward directions. These tests indicated that the maximum

casing temperature occurred when a rearward tip-over occurred. The maximum casing temperature was found on the front of the heater which was facing up and in this condition was 301°F. The temperature of the rear face in contact with the floor was only 102°F. The maximum flooring temperature occurred when a forward tip over occurred. The maximum flooring temperature found in this condition was 192°F.

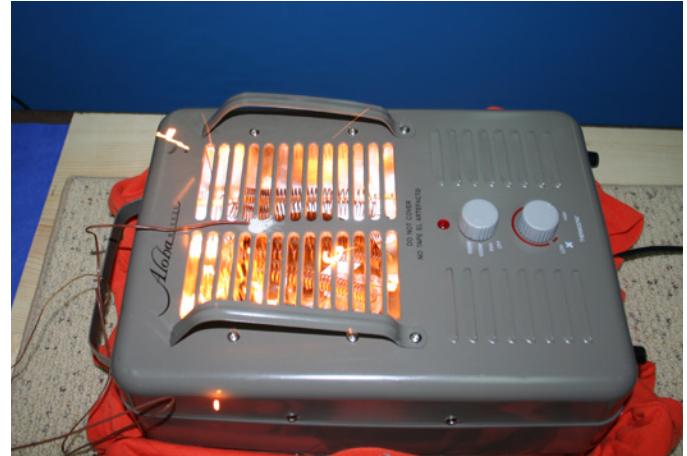
**FIGURE 10**  
Heater at moment of element shorting and fracturing

In another series of tests, it was noted that when the unit was forcefully tipped over and the heating element is hot, on some occasions, sections of the short and long heater elements can come in contact with one another. This effectively

creates a new shorter section of heating element which glows red hot. These tests indicated that by either multiple forceful blows to the heater or during an extended period of tipped over operation the heater elements could short, turn red hot, fracture and eject hot particles. This fracture and ejection is accompanied by a "pop" sound.

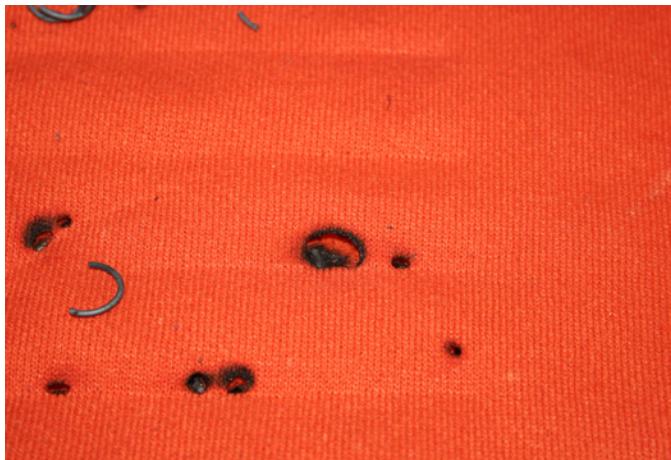
**FIGURE 11**  
Burned spots on sweatshirt under heater with fractured coil

ation of 30 and 406 minutes. The elements failed by short circuiting with subsequent fracture and ejection of hot fragments of heating element. These fragments melted and charred the sweater and carpet under the heater but did not result in noticeable flaming combustion.

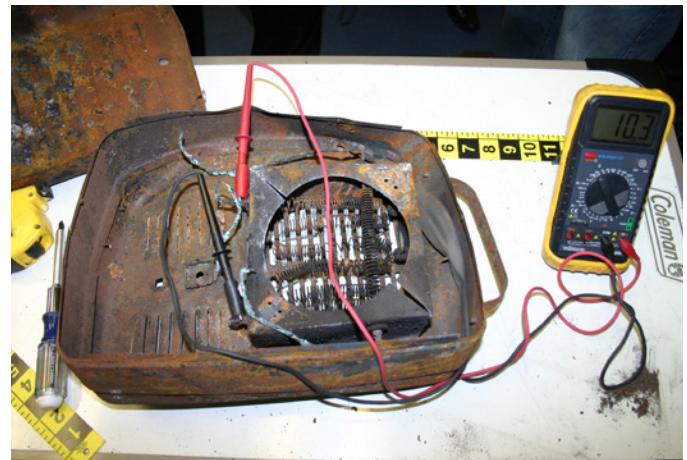
There was no electrical arcing on either the internal circuitry or the small remaining section of the power cord of the heater in question.

Both the long and short heating elements were found to be separate, completely intact and continuous without any breaks and with no electrical arcing activity or other substantial damage. Additionally, the remains of a combination thermostat/tip-over switch were found within the heater housing. Furthermore, there was a high temperature thermal fuse located within the remains of the unit.

**FIGURE 12**  
Testing of subject heater showed no evidence of shorted heater coils
