# EVALUATING FIRE DAMAGED REGULATORS:

HOW RELIABLE IS POST-FIRE TESTING?

**Jerry R. Tindal, MS, P.E.**  
THE WARREN GROUP, INC.

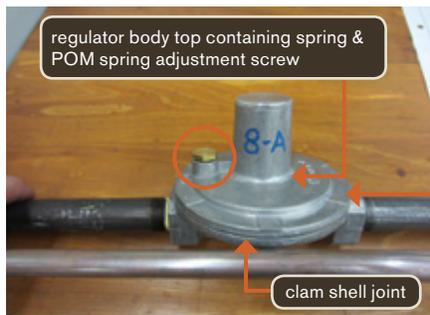
**FIGURE 1**  
Intact regulator connected for testing. Circled is the vent limiter.

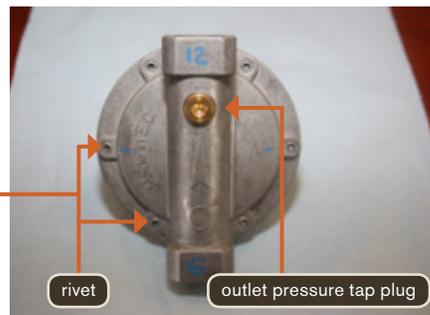
**FIGURE 2**  
Bottom of regulator. The tap plug was used to install an internal thermocouple.

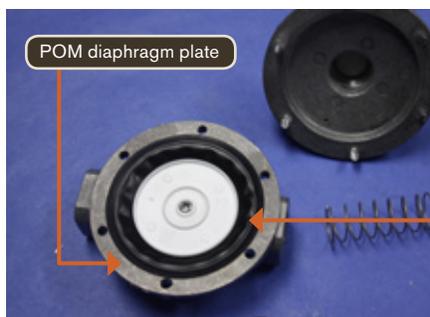
**FIGURE 3**  
Disassembled regulator. Upper body.

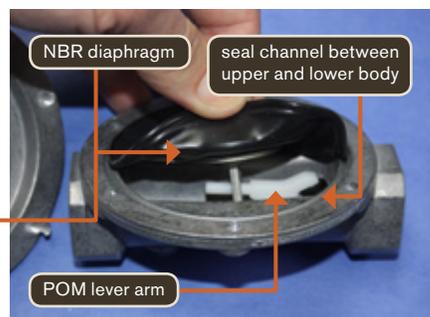
**FIGURE 4**  
Disassembled regulator. Upper body. Note flexibility of NBR Diaphragm.

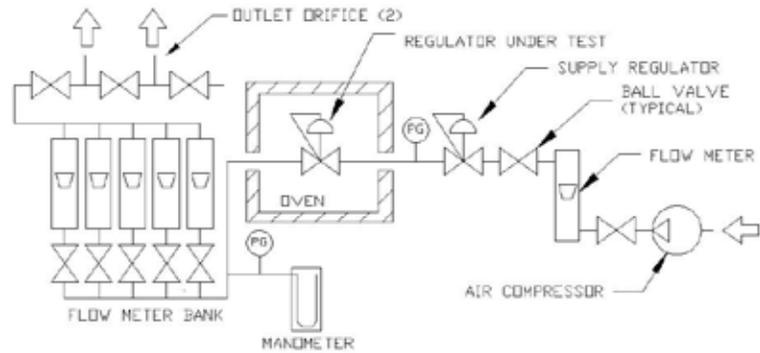
**FIGURE 5**  
Drawing of test manifold used in oven and radiant heat testing.

Figure 5 depicts a drawing of the test manifold set-up used in the oven testing. Figures 6 and 7 depict general photographs of the oven test set up. Table 2 provides a summary of the conditions to which each regulator was exposed during oven testing. The upper practical test temperature achievable with the oven was limited to approximately 600°F and therefore temperatures beyond second stage degradation of the NBR material were not reached. The enclosed nature of the oven necessitated the use of air as the regulated gas for safety purposes.

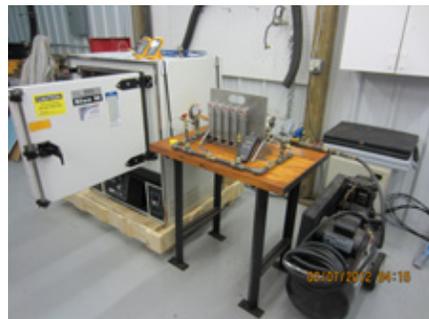
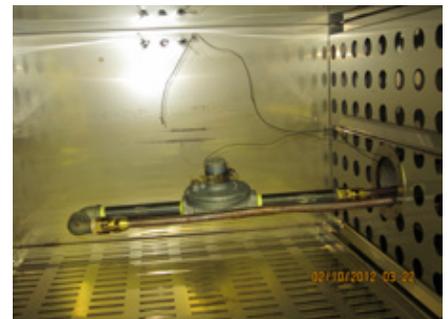
**FIGURE 6**  
Oven exposure test set-up.

**FIGURE 7**  
Oven exposure test set-up.

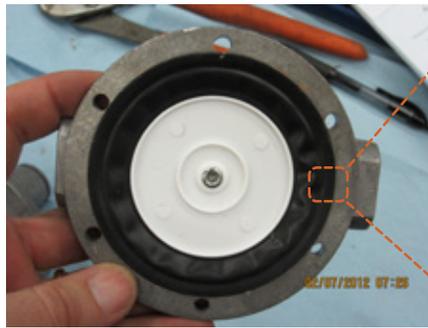
**FIGURE 8**  
POM diaphragm plate from an untested regulator.

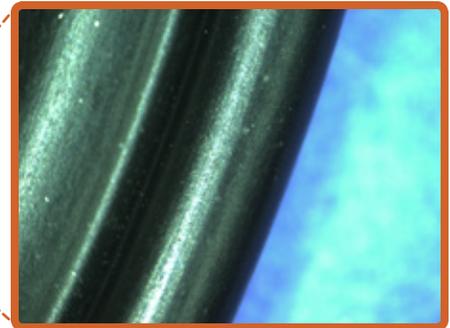
**FIGURE 11**  
Microscopic photograph of the NBR diaphragm seal ring from an untested regulator (bottom/gas side). Smooth, rounded and undamaged.

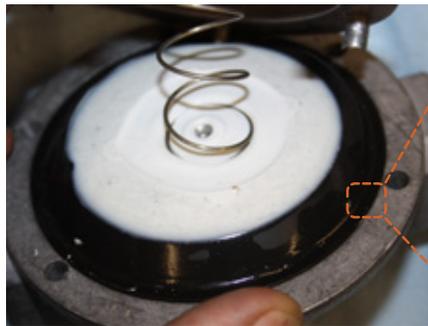
**FIGURE 9**  
Regulator from Test 4-A. No degradation of POM diaphragm plate. Melted but not discolored or embrittled.

Post-testing disassembly and examination indicated POM melting but no evidence of POM or NBR degradation. No evidence of cracking, hardening or mass loss was observed on the NBR seal ring. Although the POM components were melted, they maintained their basic shapes and the material did not flow (See Figure 9). The internal temperatures of regulators 5-A and 6-A were taken

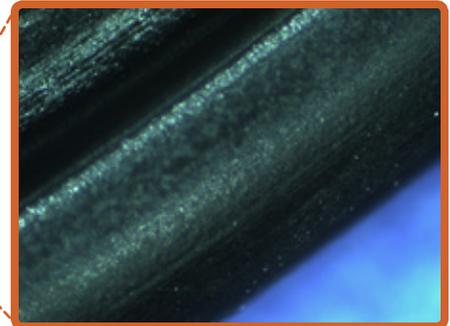
**FIGURE 12**  
Microscopic photograph of the NBR diaphragm seal ring (bottom/gas side) from Test 4-A. Smooth, rounded and undamaged.

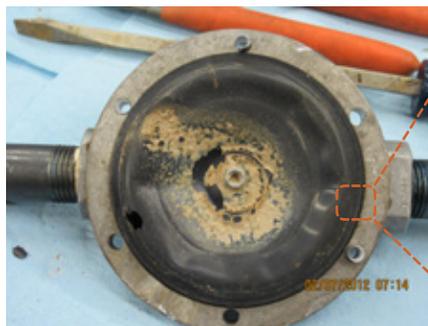
**FIGURE 10**  
Regulator from Test 8-A. Extensively degraded POM diaphragm plate with significant mass loss. Substantial hardening and embrittlement of NBR diaphragm plate. *Note the fracture on the lower left side.*

Regulator 8-A sustained embrittlement and hardening of the NBR diaphragm to the point that it broke like peanut brittle. Multiple points of cracks or splits, mass loss and substantial POM residue deposits were observed on the NBR sealing surface of 8-A. The internal temperature of 8-A was in the range of second stage degradation for a time period of approximately 8 minutes while 7-A was in that range for only 3 minutes. More significant is that the internal temperature of 8-A was above first stage degradation temperatures for 30 minutes compared to only 16 minutes for 7-A. During these

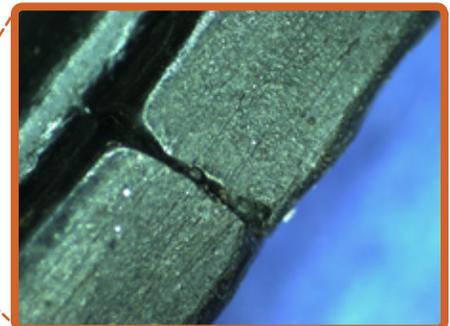
**FIGURE 13**  
Microscopic photograph of the NBR diaphragm seal ring (bottom/gas side) from Test 8-A. Compression set, extrusion, mass loss and splitting observed in the seal ring (Compare to Figures 8 and 9). The width of the seal ring is approximately 2mm.
